DILLINGHAM BOULEVARD RESIDENCES, TEIXEIRA HOUSE
1927 Dillingham Boulevard
Honolulu
Honolulu County
Hawaii

HABS No. HI-558-C

HISTORIC AMERICAN BUILDINGS SURVEY

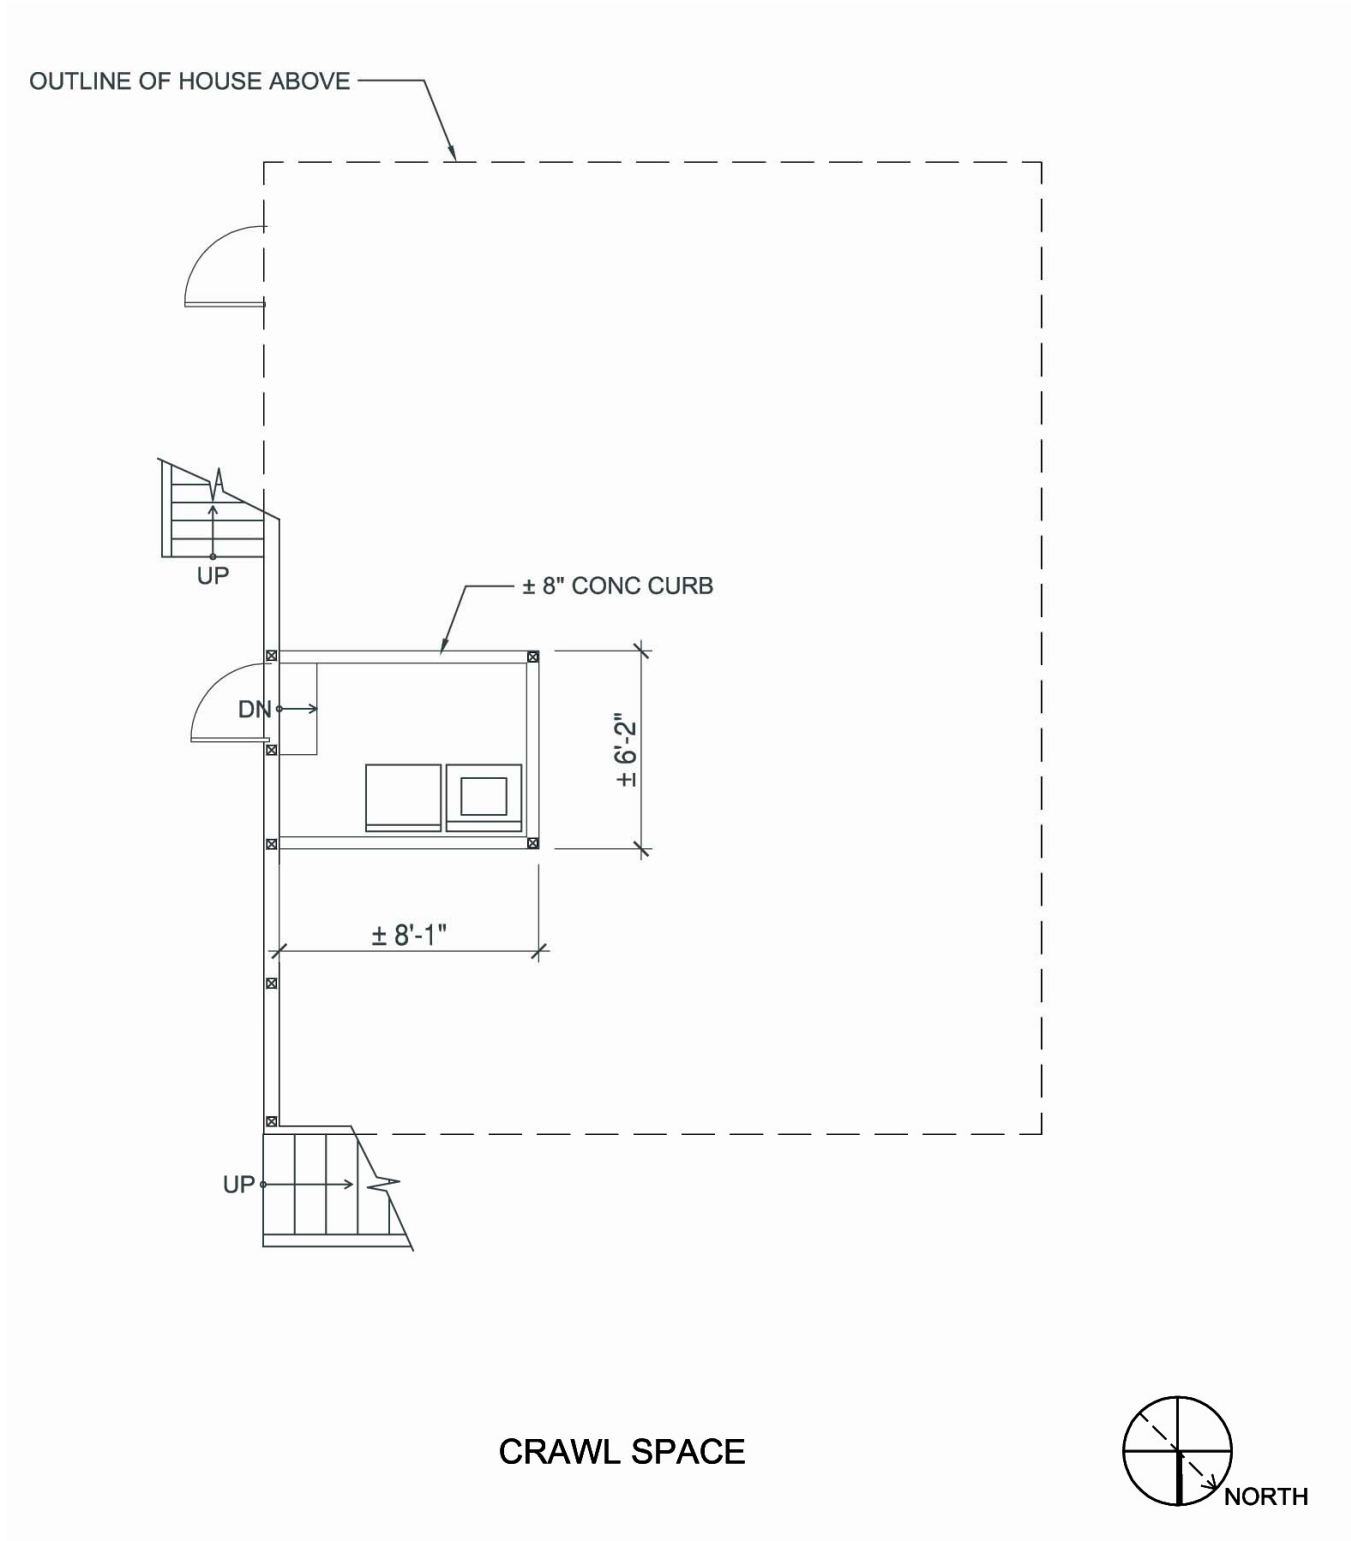
Floor Plan of Crawl Space *Mason Architects, Inc., August 2012.*

2. **Foundation and walls:** The Teixeira House has a post-and-beam foundation supported by wood posts with 4x4 nominal dimensions. The perimeter posts rest on a 4"-wide concrete curb, 5" of which is above grade. The interior posts are set atop lava rocks or square concrete blocks. The posts and diagonal braces support five nominal 4x4 beams, on which rest nominal 2x6 joists under the 3"-wide floorboards. Within the crawl space is a small (about 6' x 8') laundry area whose concrete floor is about 1'-4" below grade. The laundry area retaining walls are approximately 2' high, extending about 8" above the dirt of the crawl space. The crawl space is primarily screened in by 1" x 3" horizontal wood strips, but also with a few other materials, including wood lattice, with lath placed diagonally.

Below the main floor, there are two small doors on the southeast side of the house that lead through the foundation screening into the laundry area and the crawl space. At the bottom of the stair on this side is a flush, painted plywood door, approximately 2'-6" wide and 5' high that accesses the laundry area. The other door, directly behind the southeastern staircase, is also wood and has approximately the same dimensions. Its five horizontal members (of varying widths), along with its approximately 4" wide vertical members on either side, give the impression of a roughly made four-panel door. This door provides access to the rest of the crawl space.

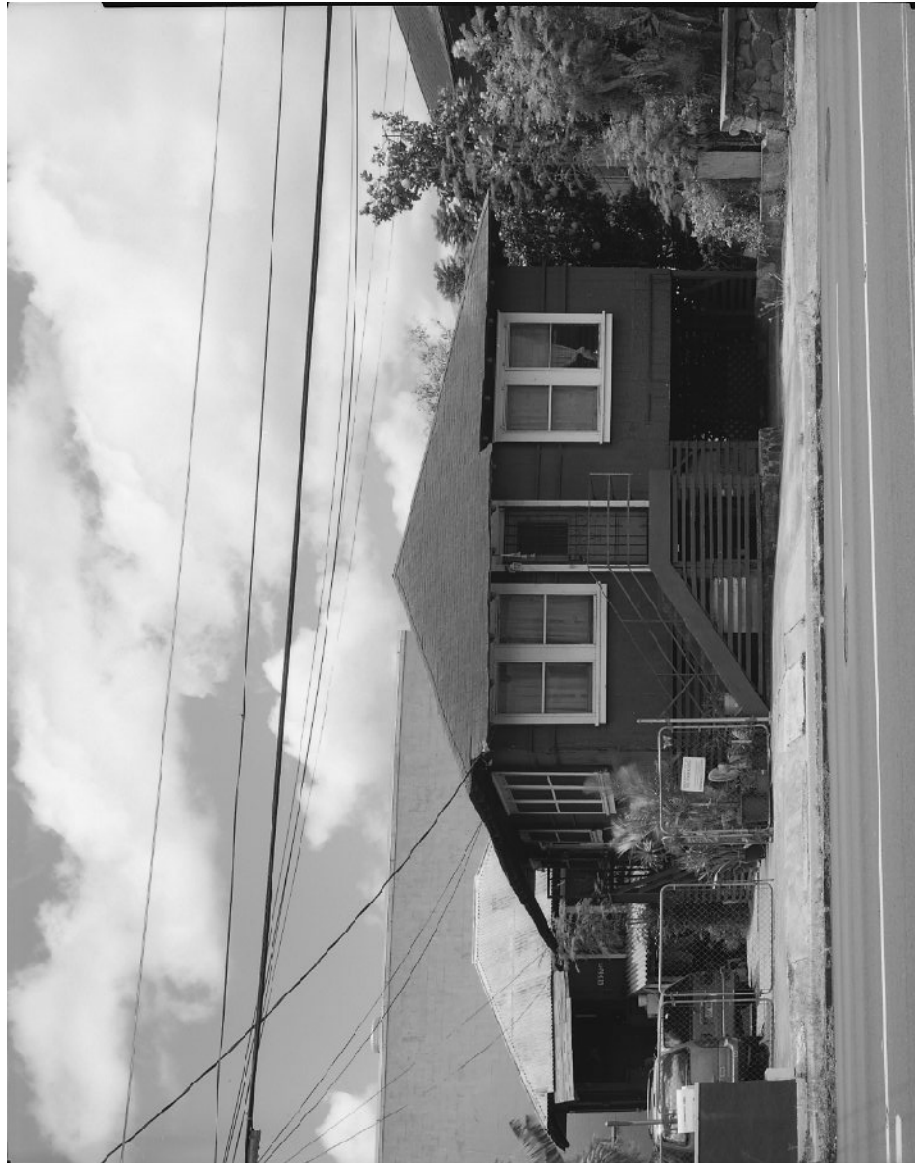
HABS No. HI-558-C-1

HI-558-C-1	FRONT ELEVATION OF TEIXEIRA HOUSE. VIEW FACING SOUTHWEST.
HI-558-C-2	OVERVIEW OF TEIXEIRA HOUSE, SHOWING ADJACENT PROPERTIES ON EITHER SIDE. VIEW FACING WEST.

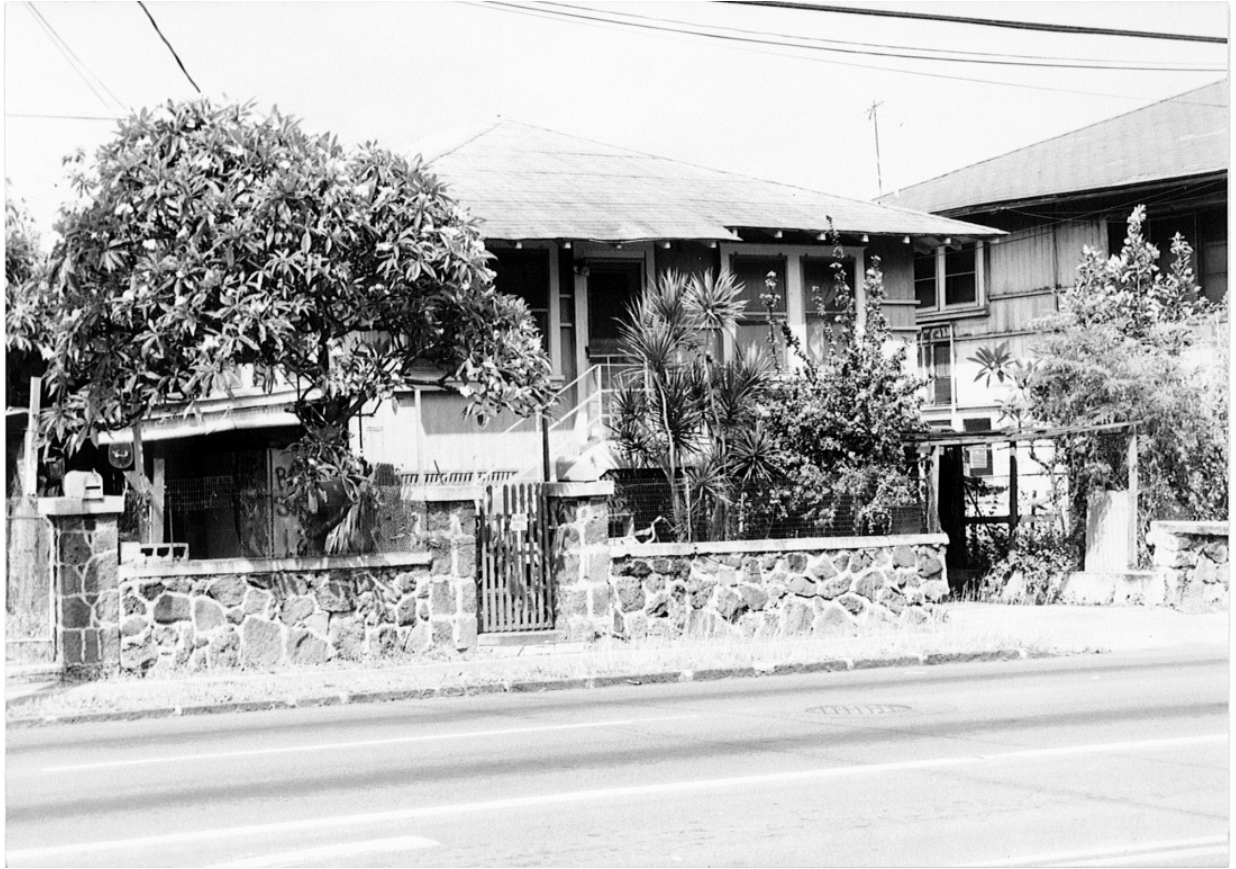
Photograph of the Teixeira Residence taken by Mason Architects, Inc. (1999) showing intact original lava rock wall.

- 1. **Exterior terrace privacy walls/fences/enclosures:** On the southeastern side of the lot, a 5'-high concrete masonry unit (CMU) wall separates the residential parcel from the adjacent commercial plaza. The rear property line is the CMU wall of the commercial building that fronts on Colburn Street. A chain-link fence approximately 6'-high extends along the property line on the northwest side of the Teixeira parcel. Along the front of the Teixeira lot, a four-section chain-link gate extends from the southeastern CMU wall to a post near the bottom of the front entry stair. A small section of lava rock wall, which appears to be of relatively new construction, is located on the east side of the carport opening. It is approximately 3' in length and 1' in height, and functions as part of the building foundation. A remnant of the original lava rock wall remains at the front property line. It is approximately 5' long, 2' wide, and 3'-6" high and is surmounted by a 4" concrete cap. Wire mesh about 5' in height is located behind this wall. Another section of wire mesh, approximately 3' in height, extends from the end of the rock wall to the north corner of the house.

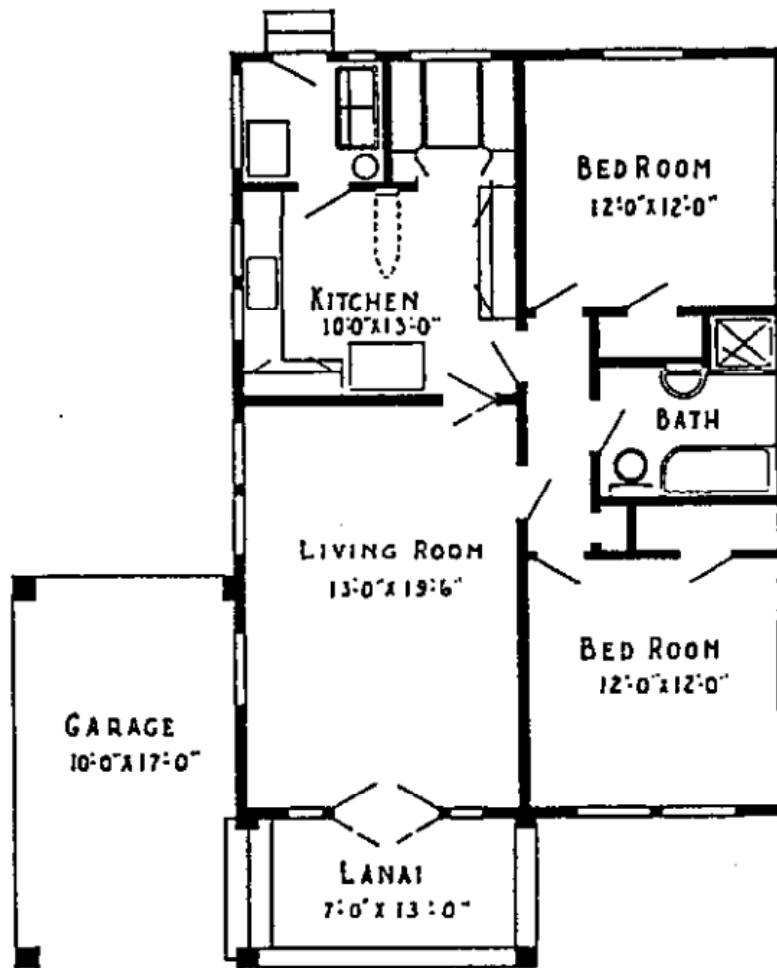
Floor Plan (875 sq. ft.) shown in *Homes In Hawaii; Suggestions for the Home-Builder* catalogue (p. 19), published by building material supply company Lewers & Cooke, Ltd. [1931].

- a) The Teixeira House is rectangular in plan. It closely resembles an 875 square foot floor plan advertised in the *Homes In Hawaii; Suggestions for the Home-Builder* catalogue (1931), as well as an even earlier plan (ca. 1921) developed by the HSPA, titled "Cottage for One Family."
- b) Dimensions: The overall dimensions of the one-story residence are 24' x 30', for a total living area of 720 square feet.

The floor plan very closely resembles the layout in an 875 square foot design advertised in the *Homes In Hawaii; Suggestions for the Home-Builder* catalogue, published by building material supply company Lewers & Cooke, Ltd., in 1931.¹⁷ In turn, the Lewers & Cooke design resembled an even earlier (ca. 1921) plan developed by the HSPA, titled "Cottage for One Family," although the HSPA design did not include a bathroom.
