HONOLULU HIGH CAPACITY TRANSIT CORRIDOR PROJECT
SURVEYED PROPERTY CONSIDERED ELIGIBLE FOR NATIONAL REGISTER

Resource Name/Historic Name: **West Oahu Christian Church/ former American Security Bank (round plan)**

Location: **94-420 FARRINGTON HWY**

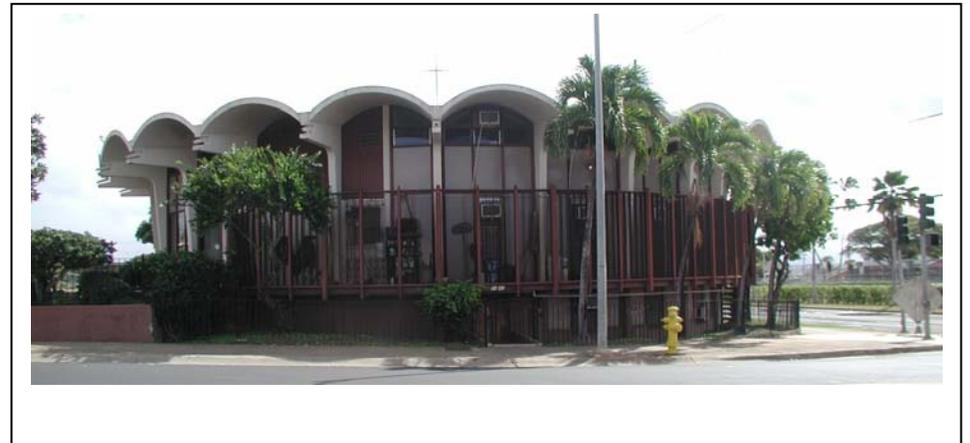
This single-story, round-plan building with a basement has a roof composed of numerous arched vaults. There is a small dome at the center, which now appears to be covered by a blue tarp. The radius of the arch in each wedge shape increases from the center towards the perimeter of the building. The vaults extend in a wide overhang around the building. The concrete supports for the roof vaults appear as tapered pilasters joined to cantilevered brackets with decorative ends. Square-section tapered downspouts project outward above each bracket end, draining water from the valleys of the roof. The building's perimeter wall sections, between roof supports, have various combinations of large fixed-light windows, double doors with large single lights, solid panels (some with window a/c units), and panels with vertical striations. The building is sited on a slightly sloping grade, with its main entry near grade level on the northwest side. The site slopes down to Farrington Highway on the south side where there are steps down to an entry at the basement level. There are basement windows on this side of the building. Most of the upper-level exterior walkway has a high fence

Main building appears relatively unaltered, except for air conditioners and other changes in walls. In 1977 an underground fallout shelter was added to the parcel - entry is at base of the vertical concrete signage along Waikele Road.
